## ***Comprehensive Hazardous Material Survey***

***WHITE SANDS MISSILE RANGE  
BUILDING 20854***

***SAFENET ENVIRONMENTAL SERVICES, LLC.  
DECEMBER 18, 2002***

***SES Project No. 2N355***

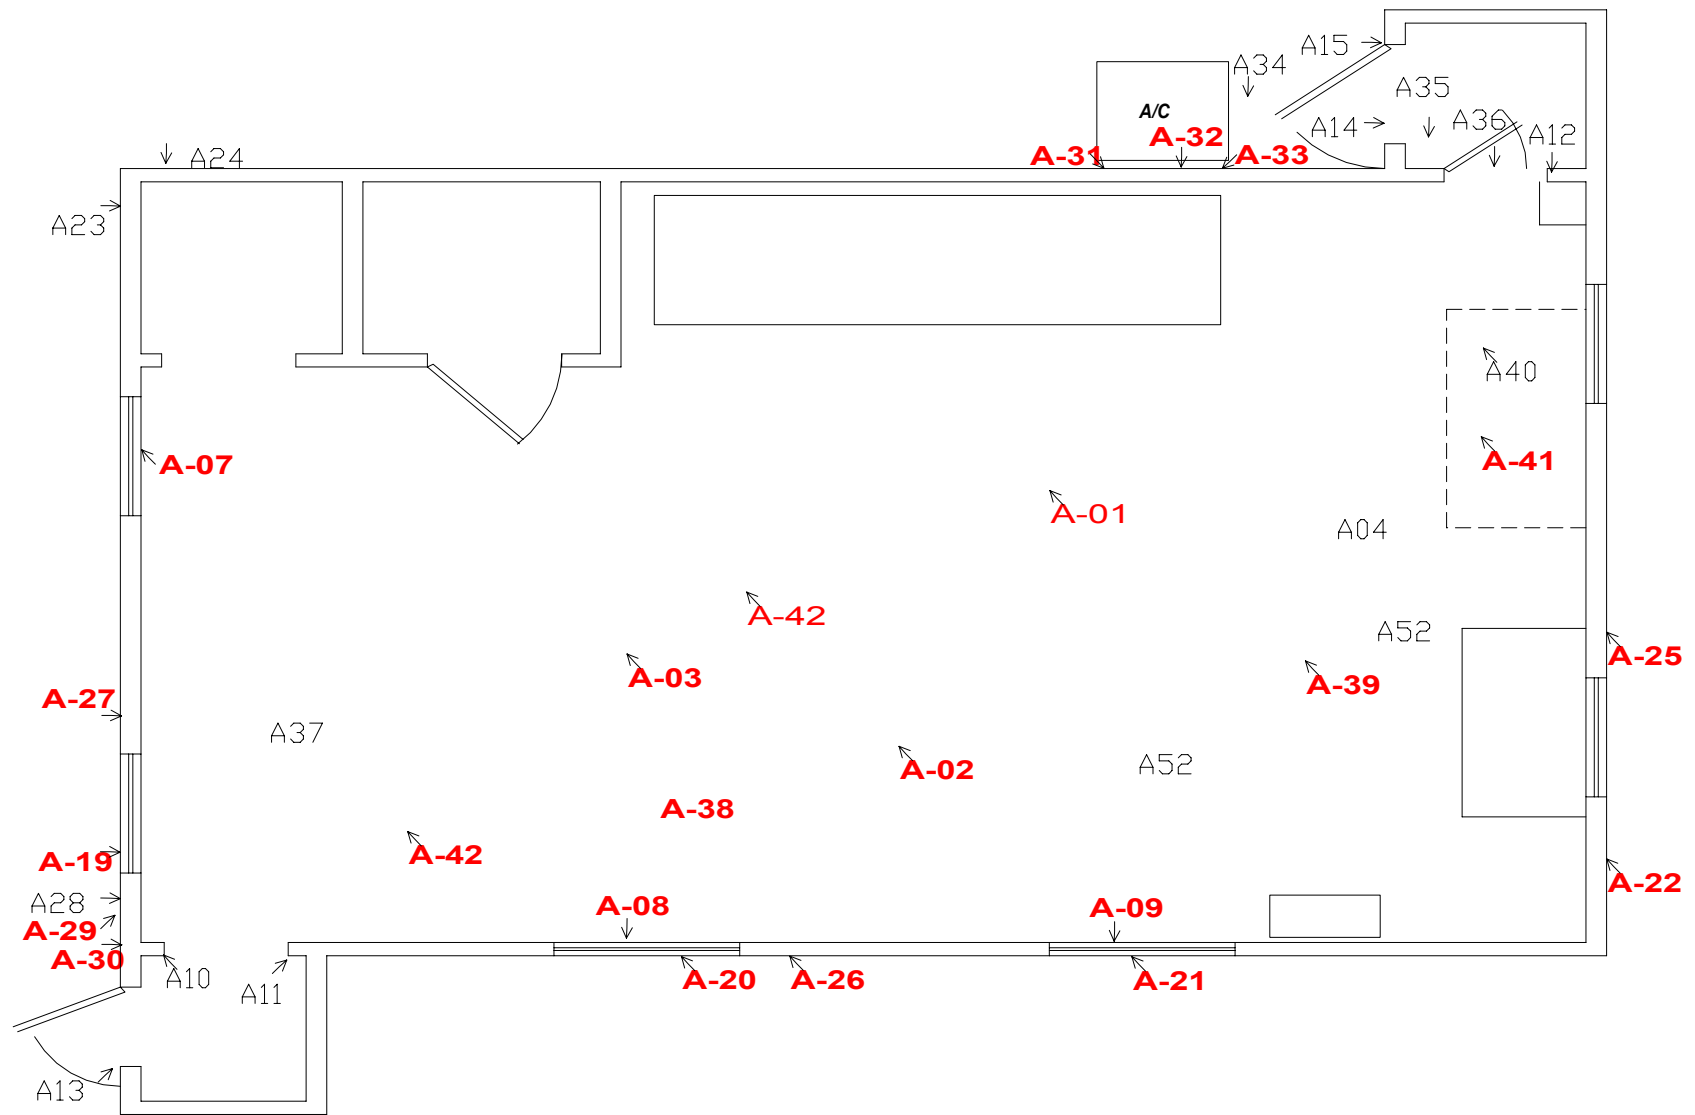
Drawing  
 # 1

Asbestos Sample Locations  
 Bldg. 20854  
 WSMR

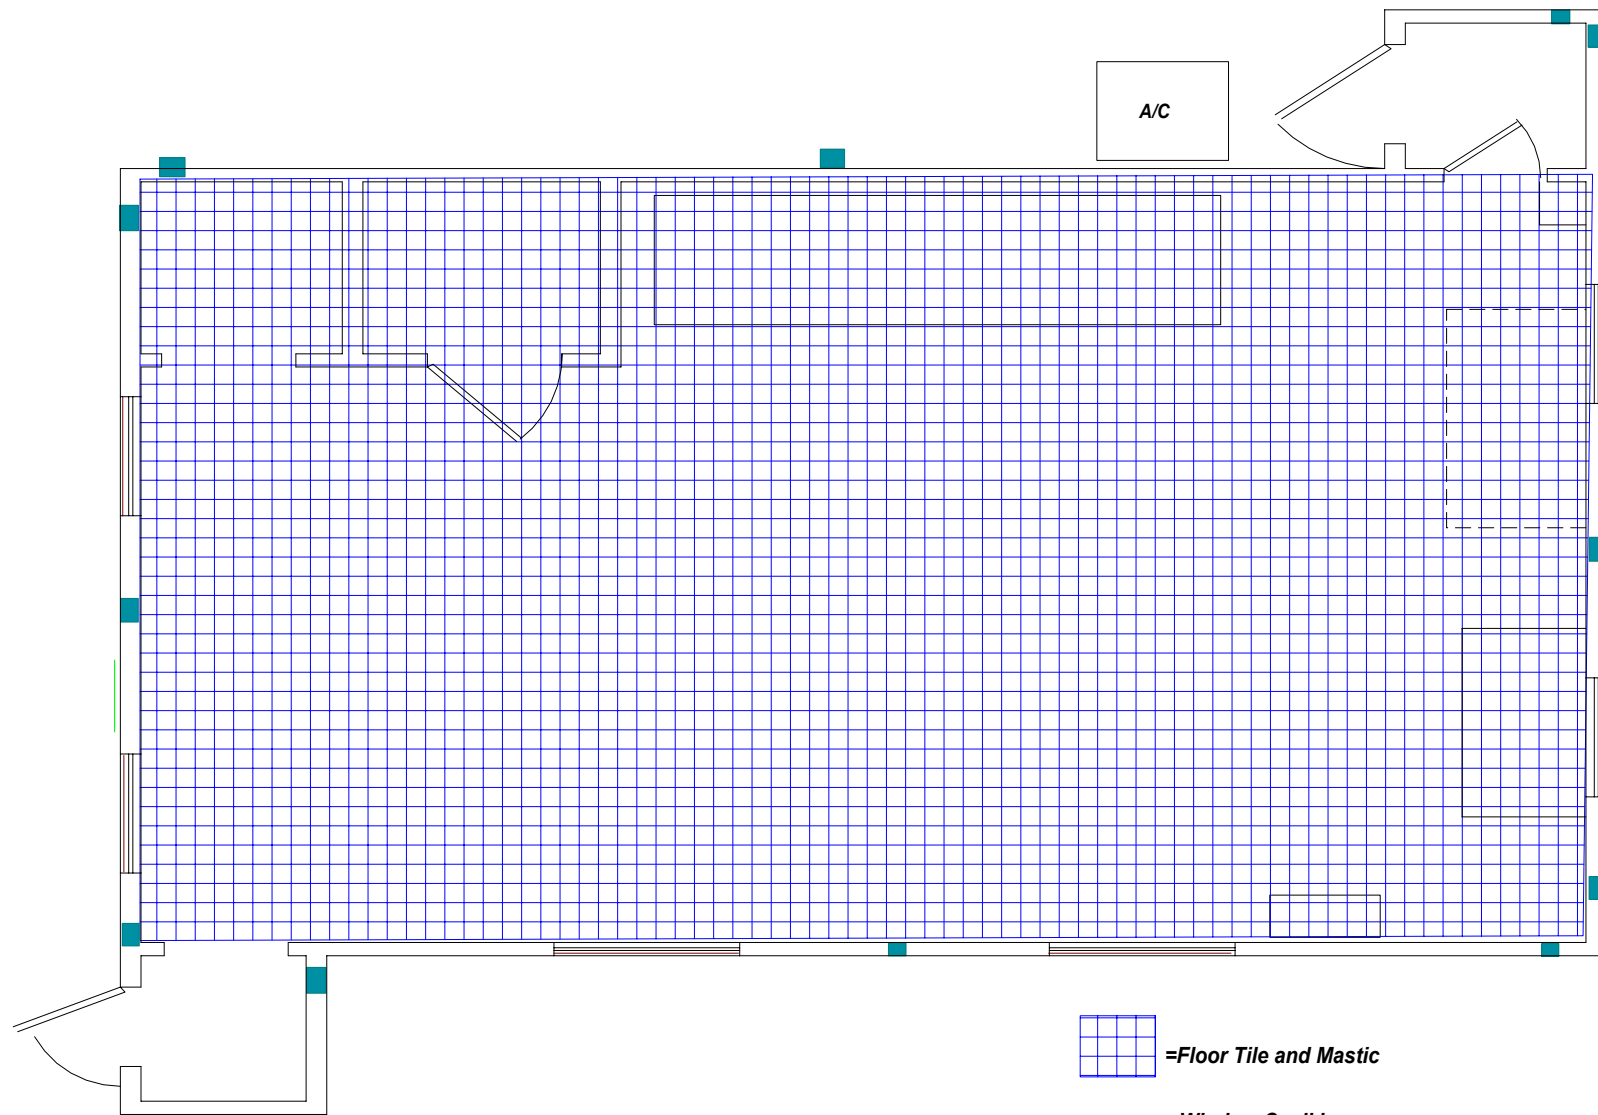
Drawing  
# 2

=Floor Tile and Mastic
-

=Window Caulking
-

=Mudding Compound @ Penetrations
-

=Sealant on CMU

Asbestos Homogeneous Locations  
Bldg. 20854  
WSMR

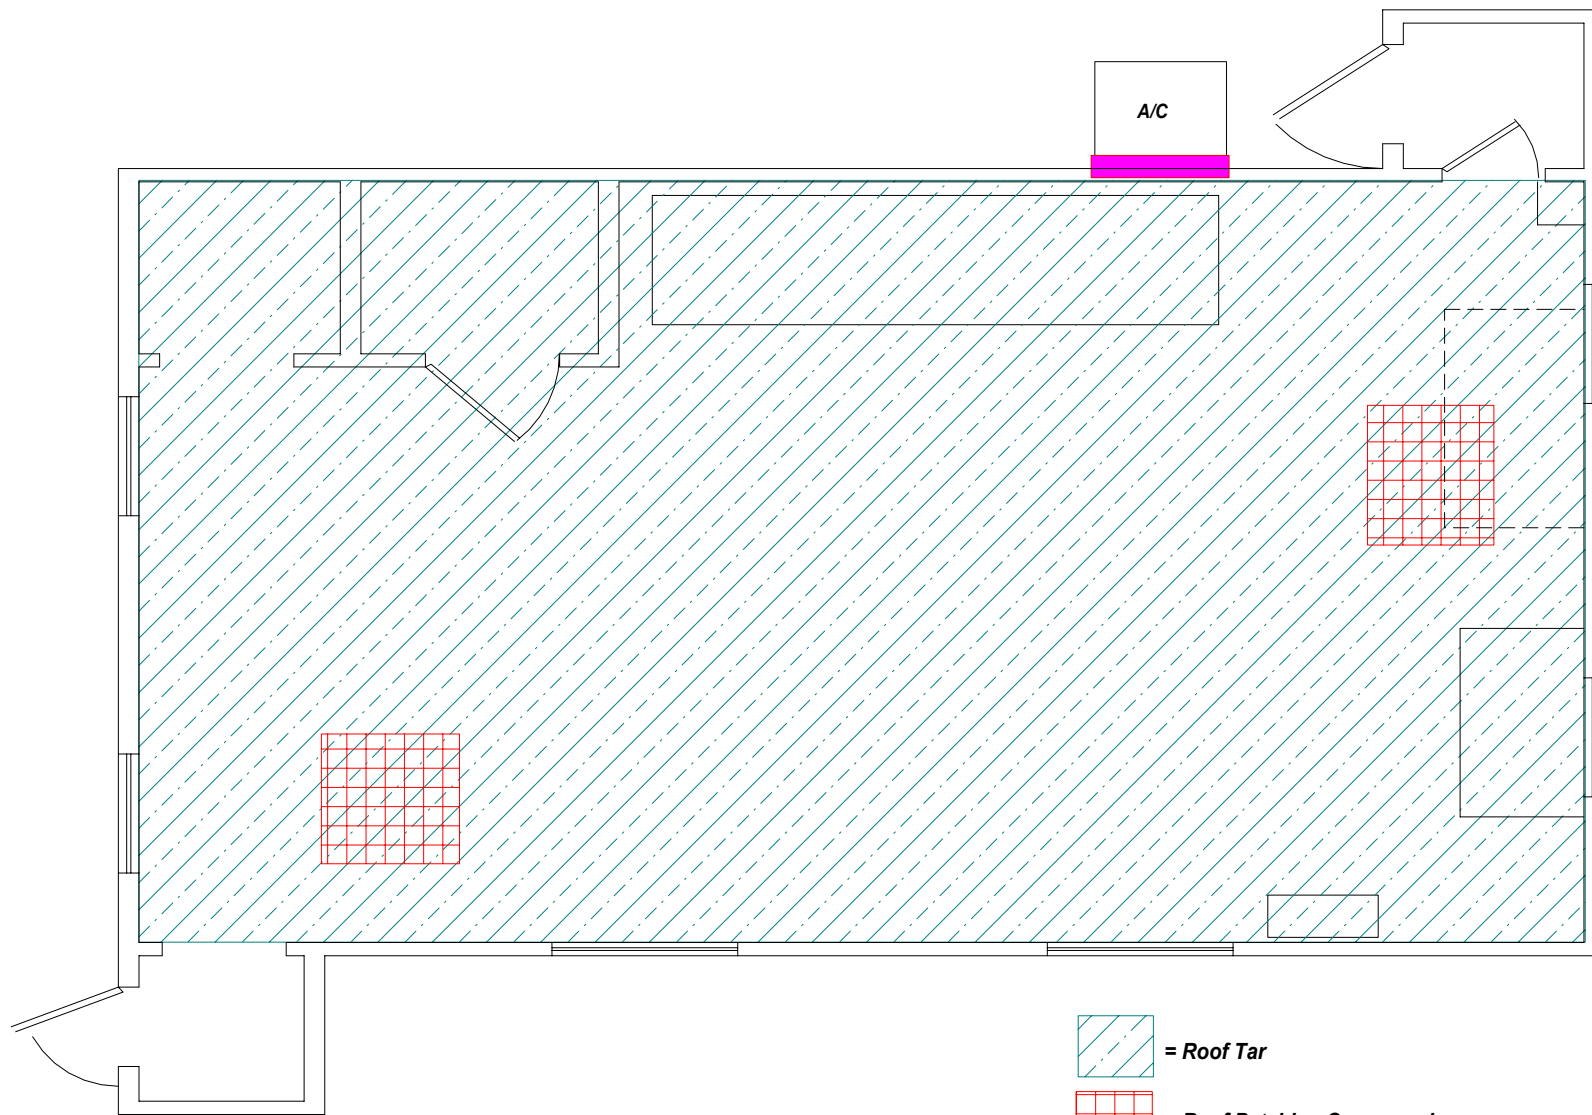
Drawing  
 # 3

= Roof Tar
-

= Roof Patching Compound
-

= Flex Connector

**Asbestos Homogeneous Locations**  
**Bldg. 20854**  
**WSMR**

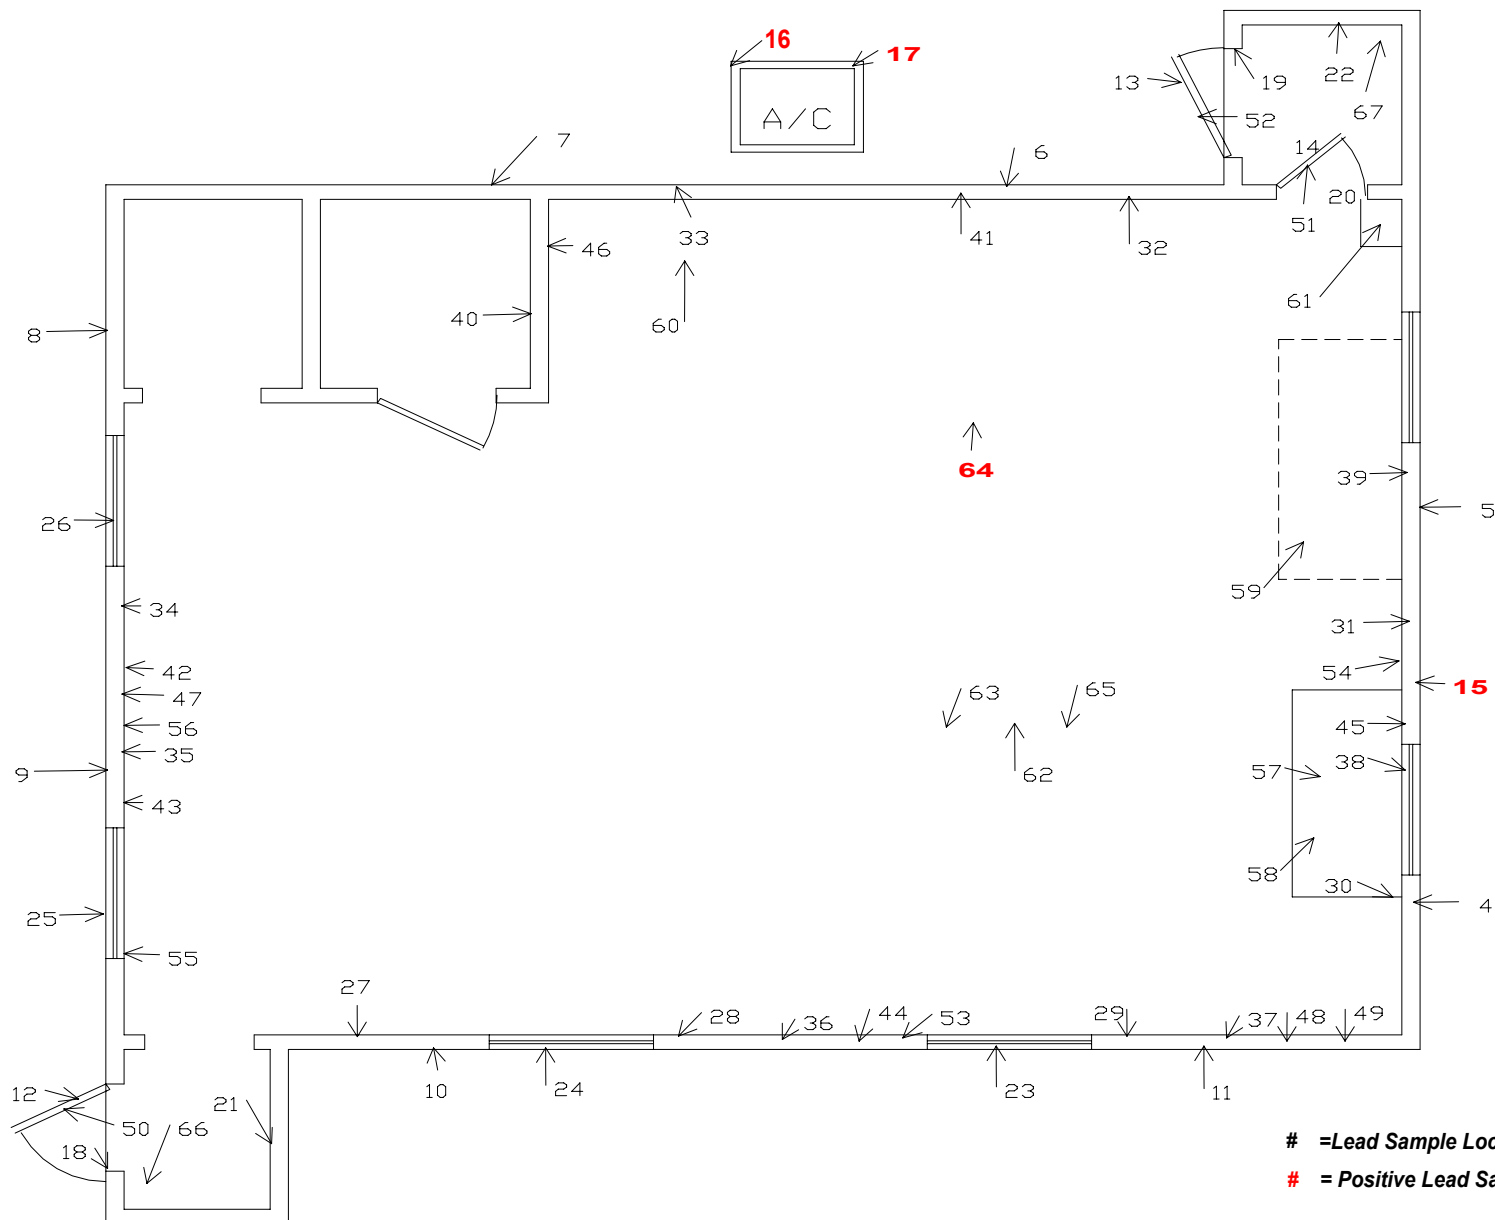
The lead based paint analysis with the XRF Spectrum Analyzer indicates that lead paint was detected on the following; exterior wall-wood (white paint), metal A/C stand (green paint), and metal joists (orange paint). The workers involved in the renovation and disturbance of components containing lead must be trained, utilizing the methods of compliance prescribed by 29 CFR 1926.62 for removal and disposal.

# =Lead Sample Locations

# = Positive Lead Sample Locations
